Contract #: 04-0120F4Cty: SF/ALA Rte: 80 PM: 13.2/13.9File #: 69.28**WELDING INSPECTION REPORT****Resident Engineer:**Pursell, Gary**Address:** 333 Burma Road**City:** Oakland, CA 94607**Report No:** WIR-011948**Date Inspected:** 04-Feb-2010**Project Name:** SAS Superstructure**OSM Arrival Time:** 700**Prime Contractor:** American Bridge/Fluor Enterprises, a JV**OSM Departure Time:** 1900**Contractor:** Zhenhua Port Machinery Company, Ltd (ZPMC), Changxing Island **Location:** Shanghai,China**CWI Name:** Mr.You Qi Guo**CWI Present:** Yes No**Inspected CWI report:** Yes No N/A**Rod Oven in Use:** Yes No N/A**Electrode to specification:** Yes No N/A**Weld Procedures Followed:** Yes No N/A**Qualified Welders:** Yes No N/A**Verified Joint Fit-up:** Yes No N/A**Approved Drawings:** Yes No N/A**Approved WPS:** Yes No N/A**Delayed / Cancelled:** Yes No N/A**Bridge No:** 34-0006**Component:** Tower**Summary of Items Observed:**

IN PROCESS INSPECTION:-**TOWER TRAIL ASSEMBLY AREA:-****SOUTH SHAFT LIFT 1:-**

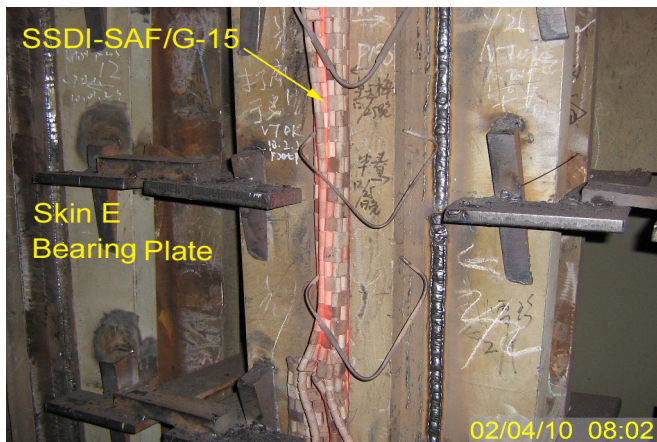
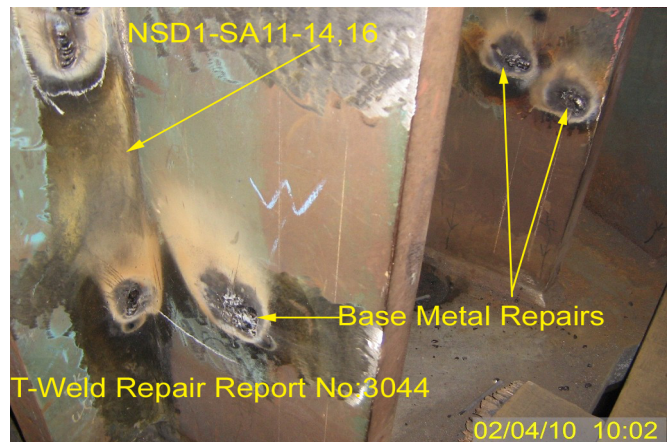
FCAW welding of weld joint no: SSD1-SA17F/G-27 located on Skin C Bearing Plate. Welder is identified as 054069.ZPMC QC is identified as Mr. Sun Zi Wang. The welding variables recorded by QC appeared to comply with the WPS-B-T-2333-TC-P4-F.

FCAW welding of weld joint no: SSD1-SA18-11 located on Skin B Bearing Plate. Welder is identified as 201825. ZPMC QC is identified as Mr. Sun Zi Wang. The welding variables recorded by QC appeared to comply with the WPS-B-T-2333-TC-P4-F.

FCAW welding of weld joint no: SSD1-SA16F/G-15 located on Skin E Bearing Plate. Welder is identified as 052075.ZPMC QC is identified as Mr. Sun Zi Wang. The welding variables recorded by QC appeared to comply with the WPS-B-T-2333-TC-P4-F.

ZPMC performed Base metal repair of Bearing Plate located on Skin B (NSD1-SA11 -14, 16). The base metal repair areas were approximately 3mm depth and 50mm length at 3 random locations. The material is A 709M Grade 345 Non-SPCM. Welder is identified as 070724.ZPMC CWI is identified as Mr. You Zhi Guo. Welding was been performed against welding repair report T-WR3044. The welding variables recorded by QC appeared to comply with the WPS-345-SMAW-3G (3F)-Repair.
